Close-range Photogrammetry Project - Architectural Restoration of an Ontario Hydro Building

A Project report by Frank Artés

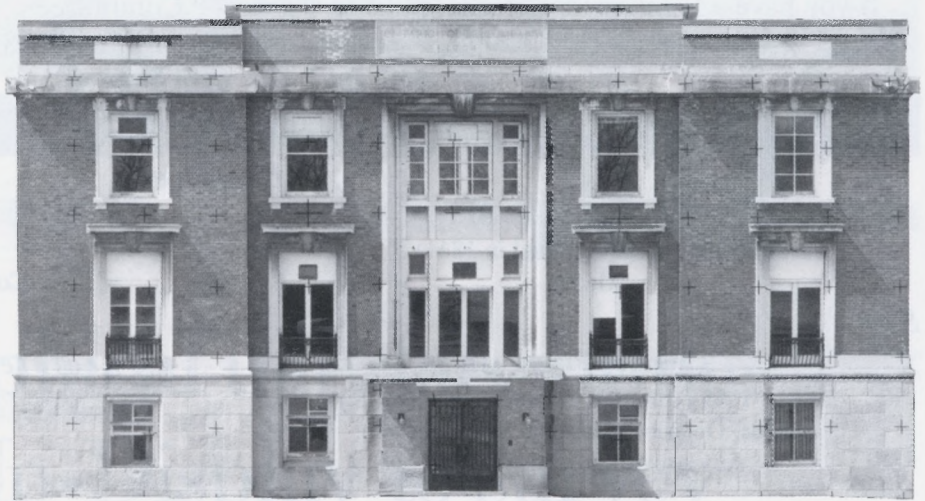
Erected in 1904, it was built in the Georgian Revival style made popular during the early 20th century, and follows a symmetrical design of a large central entrance, with a window-over-window pattern on successive floors.

It is located on an eight-acre parcel of land that was once owned by the Michigan Central Railway. As the former Niagara District and Regional Office, it is constructed primarily of

brick and stone, and affords a fine view of both the Canadian and American Falls. It houses office space and machine shops, with underground communication and electric cables to the Niagara transformer station.

Fine detailing is restricted to the moulding around the large portico windows, which flank the central structure, the segmented transom above the main doors, and the parapet, all of which are constructed using carved stone. A copper monitor on the roof is composed of lattice-work panels and cornice moulding on the crown. Ornate metal railings over selected windows are also evident.

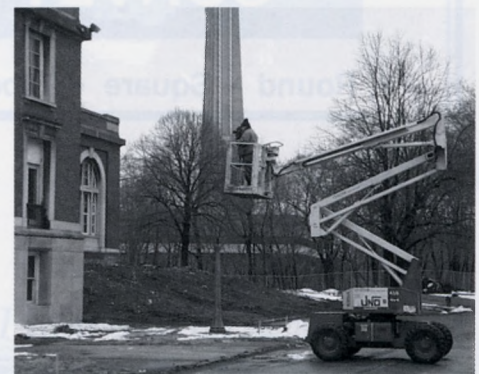
The building is approximately 20 metres high and would require two lines of stereo photography to ensure complete coverage. To meet the 5mm accuracy requirement, a photo scale of 1:200 was chosen for the first line of

photography. This would take in the foundation level to the top of the parapet wall. The second line of photography would be at a scale of 1:100, and cover the top floor and monitor, which are set back five plus metres from the face of the building.

It was decided to use a cherry picker as the camera platform, elevated 10 metres above ground level, to take the first line of photography. By positioning the camera at this location relief displacement in the images would be minimized. The second line of photography would be taken from the parapet level, as close to the parapet edge as possible.
